Differential Settlement Problem of Buildings on the Rock and Filling

Abstract:

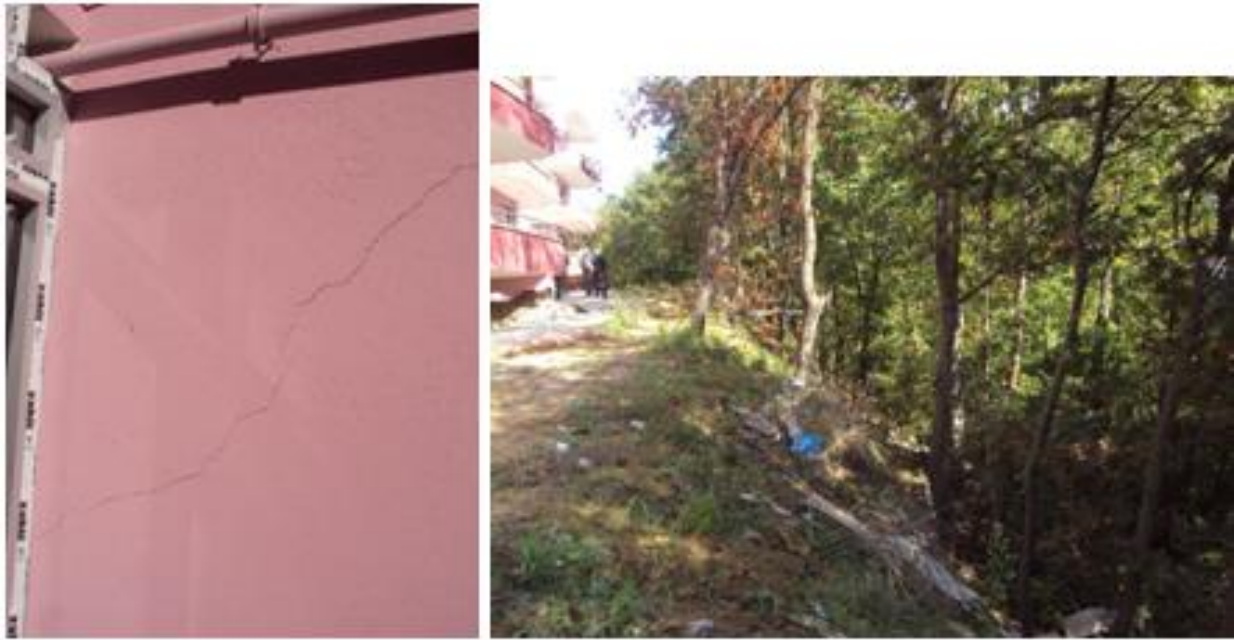
A 3-storey building in Camili region was examined in this study. Firstly, existing soil investigation report, architectural and structural design projects were investigated. Next, the cracks and damages on the building were observed by visiting the site. In Figure 2, the crack on the entrance of the building and the filling can be seen.

Figure 2. Settlement crack and filling on the slope

Adapazarı is notorious for its inferior top soils. Many people have blamed soil conditions for the destruction that appeared after the August 1999 earthquake and new residences have been encouraged to be built at the north of the city which has better soil conditions. However, after the earthquake, some settlement problems have been appeared in even static conditions although the buildings have been constructed where soil conditions are good. Survey of damage has shown that damage arising from foundation soils is not significant when compared with destruction due to inadequate structural design and building techniques. It is clear that reasonably high structures can be built in soft soils of Adapazarı with proper foundations and design. It is also concluded from this study that it is necessary to have a homogenous soil conditions under foundations on filling to prevent differential settlements.

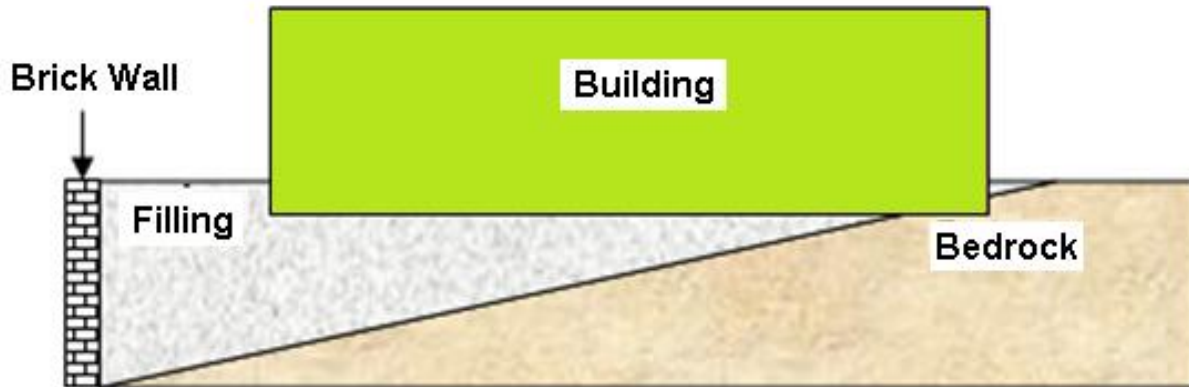
According to the borings, It has been understood that some parts of the buildings were directly seated on the bedrock while the other parts on the filling. Starting from the existing ground level, the depth of the filling has been determined to be between 3.50 m – 2.20 m at the front side of the building and around 2 m at the center of the building. It has also been determined that there is no filling at the backside of the building and foundation was directly seated on the bedrock (Figure 4).

Figure 4. A-A section for the building

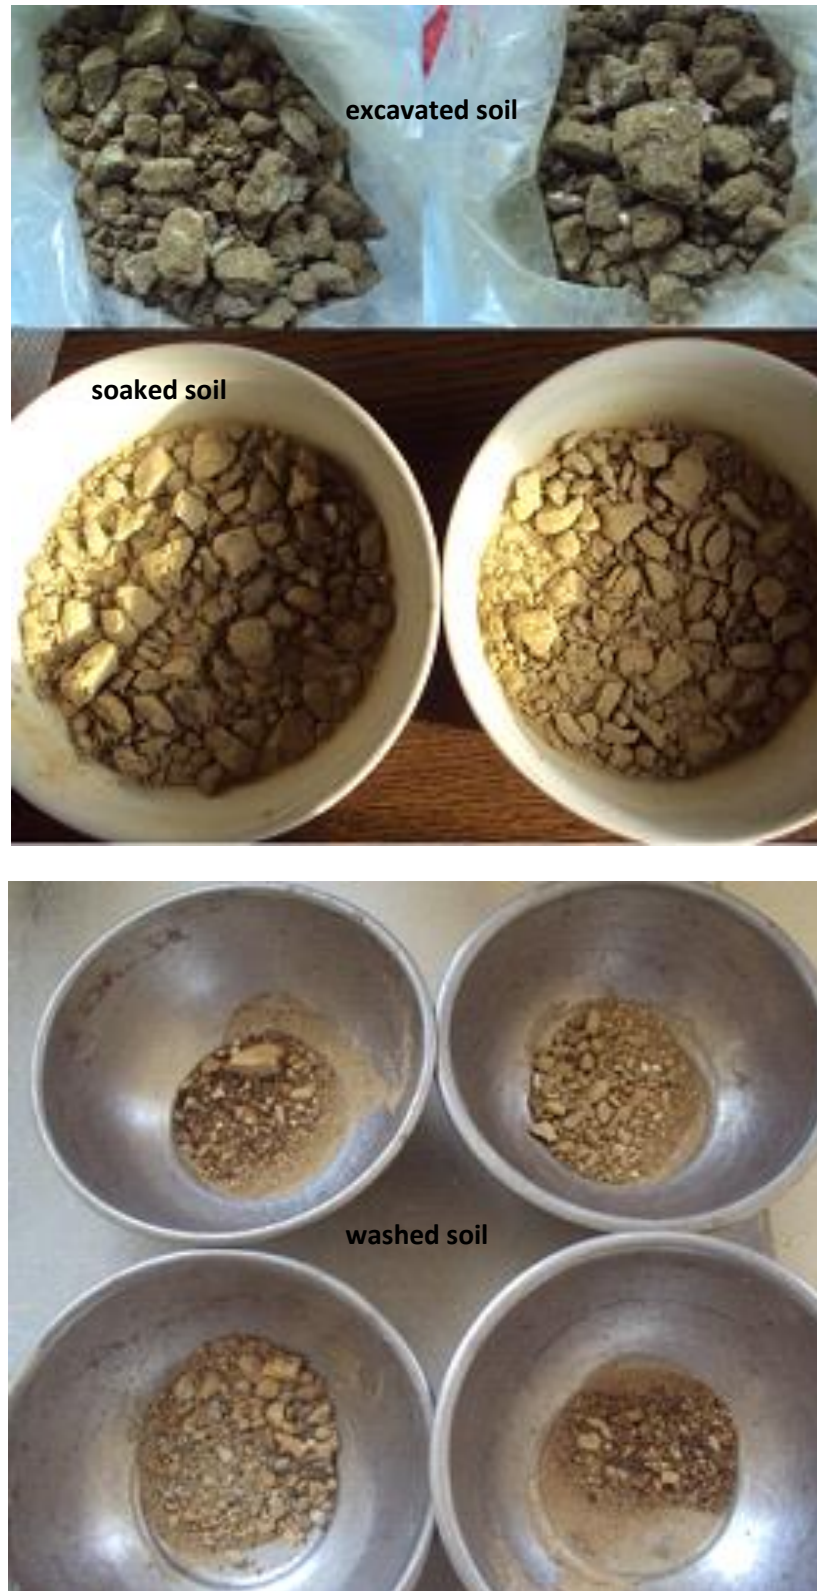
After investigating the samples, it was concluded that the soil was used as backfill material because all of the samples have a CI - intermediate plasticity clay symbol according to TS1500/2000 (CL - according to ASTM). While the samples had contained fractured rock at the beginning, it was observed that they had a tendency to break when they were soaked in water. The results of wet sieving tests confirmed this information (Figure 5). It can be interpreted that the clayey fill material had a tendency to have a differential settlement after becoming saturated with heavy rains. The residents of the building confirmed that the cracks became more visible just after the heavy rain in fall months of 2010.

Figure 5. Breakdown of weathered rock with soaking and remaining part after washing
