Seismic Performance Evaluation of a Train Station Building Considering Earthquake-Induced Pounding Effects

Abstract

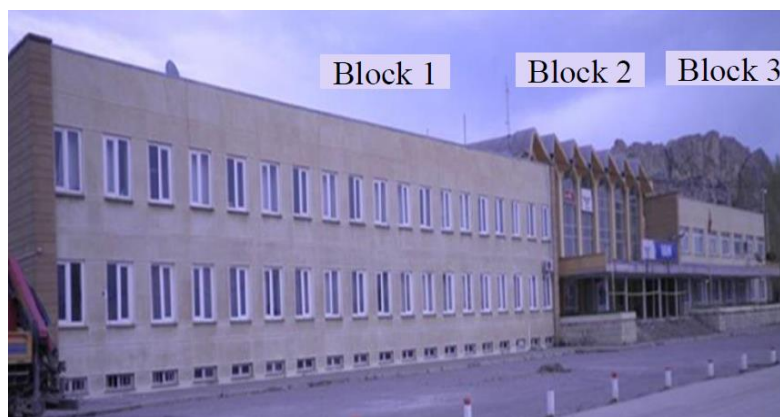
In the first and third blocks, shear damages were observed over the walls. However, the structural elements of these buildings were not damaged during the earthquake. In the second block, damage at the beam-column joints and pounding damage were observed as shown in Figure 4 [9]. There was not sufficient gap between blocks. For these reasons, the second block came into contact several times to other blocks during the 2011 Van earthquakes. Therefore, performance evaluation is only performed for the second block.

Figure 2. Train station building experienced damages in 2011 Van earthquakes [9]

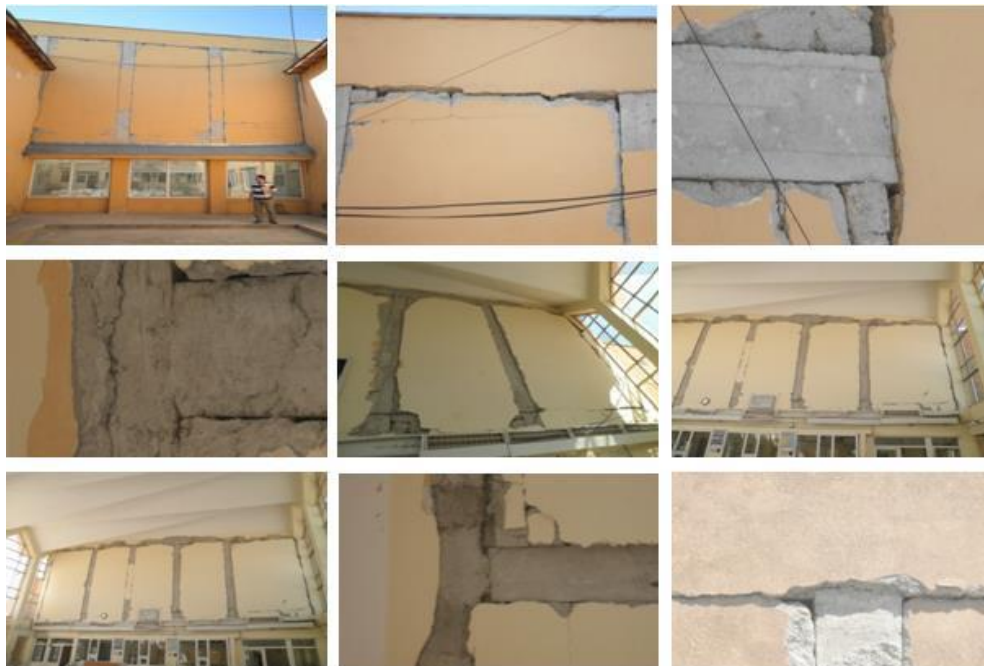
Figure 4. Damage to column-beam joints and walls in the second block [9]

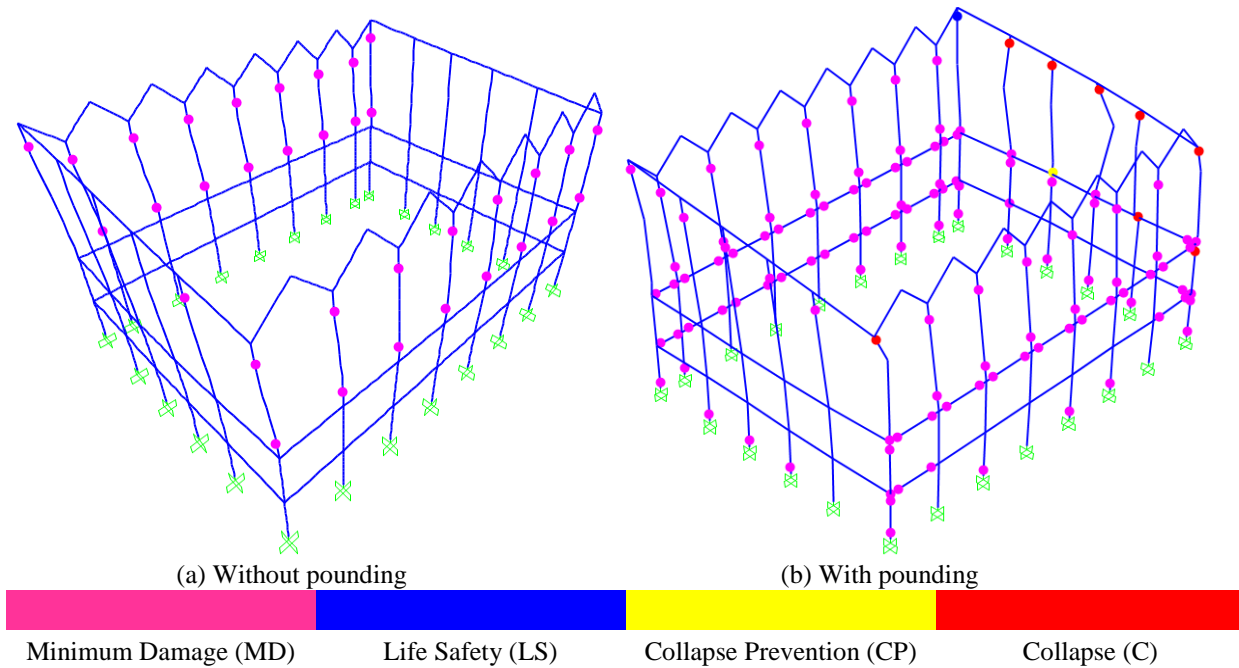
It is seen from Fig. 6 that the plastic hinges occurred at contact direction of the Block 2 after the nonlinear time history analysis. It is shown from Fig. 6a that the plastic hinges are obtained without considering earthquake-induced pounding effects. Moreover, the plastic hinges which are obtained by considering earthquake-induced pounding effects are presented in Fig. 6b. According to the results given by Figure 6, plastic hinges are concentrated at the zone of potential impacts due to earthquake-induced pounding.

Figure 6. The plastic hinges distribution occurred at x-direction of Block 2 after the nonlinear time history analysis

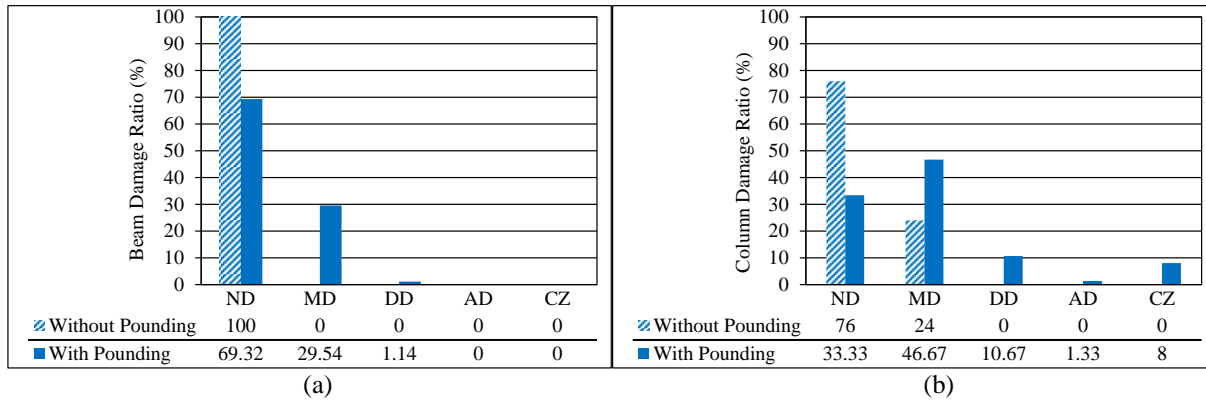
The damage zones of beams and columns for contact direction of Block 2 are presented in Fig. 7 for without and with pounding case. In the case where pounding is not taken into account, it is shown from Fig. 7b that there was no damage in 57 columns (%76), minimum damage occurred in the 18 columns (%24). Also, there was not happen distinctive damage, advanced damage and collapse in the columns. According to the results given by Fig. 7a, damage did not occur in the beams.

In the case where pounding is taken into account, it can be seen from the results of the nonlinear time history analysis in the contact direction (Fig. 7a) that there was no damage in 61 beams (%69.32), minimum damage happened in 26 beams (%29.54), and distinctive damage happened in 1 beam (%1.14). Advanced damage and collapse did not occur in beams. It is shown from Fig. 7b that there was no damage in 25 columns (%33.33), minimum damage happened in 35 columns (%46.67), distinctive damage happened in 8 columns (%10.67), advanced damage occurred in 1 column (%1.33), and 6 columns (%8) collapsed.

According to TEC-2007, whereas a train station building under maximum earthquake must be satisfied life safety (LS) performance level, the structure under design earthquake must be satisfied immediate occupancy (IO). When the damage zones of structural elements which are determined performance evaluation of the train station building using nonlinear time history analysis are investigated, Block 2 is in the immediate occupancy (IO) performance level for the case where pounding is not taken into account. However, performance level of Block 2 is determined as collapse (C) for the case where pounding is taken into account.

Figure 7. Damage zones of (a) beams and (b) columns through the x direction of the block 2 obtained from nonlinear time history analysis
