On-site Safety Considerations for Scaffoldings: A Case Study

Erkan Dogan^{1*}, Sadik Alper Yildizel and Mehmet Ali Yurdusev¹
¹Manisa Celal Bayar University, Engineering Faculty, Manisa, Turkey

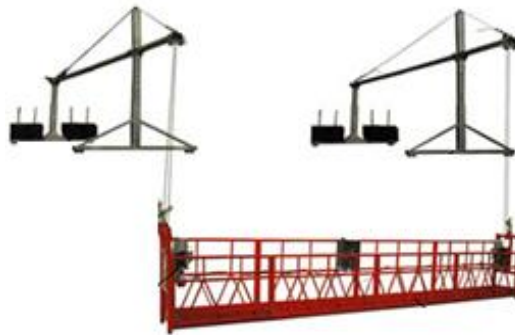
That the platform on which the work is done, moves safely along the facade and ensuring the state of equilibrium are achieved by anchoring the suspensions legs on terrace to the bridge floor concrete (Fig. 1) The life ropes tied to a constant point on terrace are suspended along with the platform movement direction at the facade in order to ensure the safety in the event of any negative situation for the workers who work on the platform.

Figure 1 Suspended scaffolding suspension leg

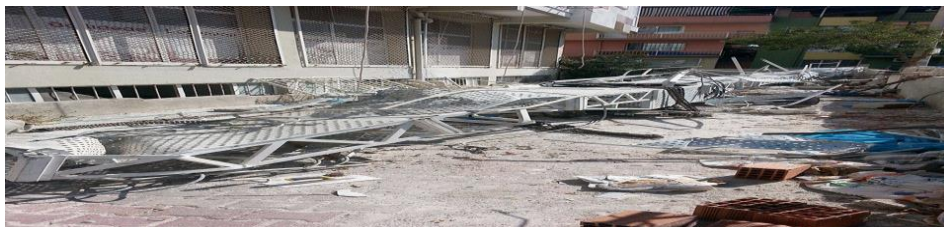
Two scaffoldings with the same dimensions and properties were used in the building for the maintenance and repair (exterior insulation) works. The scaffolding available to operate during the exploration and the scaffolding where the accident occurred are located at the different fronts. (Fig. 2).

Figure 2. Side facade of building, Rear facade of building

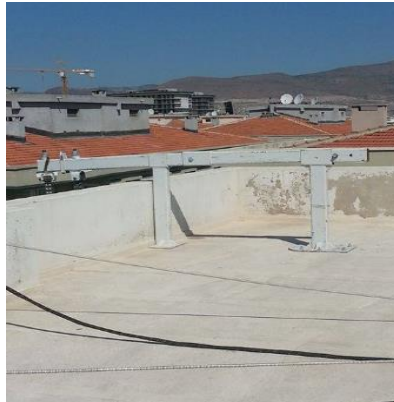
The scaffolding in investigation was fixed to the building by means of two suspension legs on the terrace. (Fig. 3).

Figure 3. Suspension leg connection

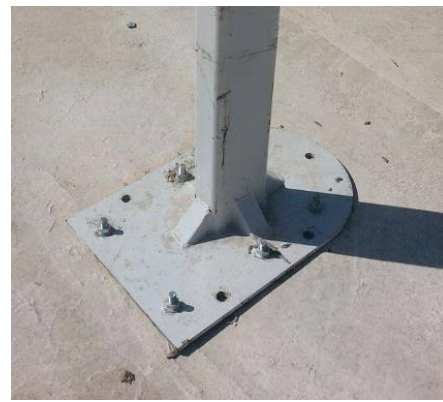
Figure 4. Bridge floor concrete and base plate connection

As shown in Figure 4, the connection of suspension legs to the building is provided by 6 chemical dowels/anchors used between base plate and the bridge floor.

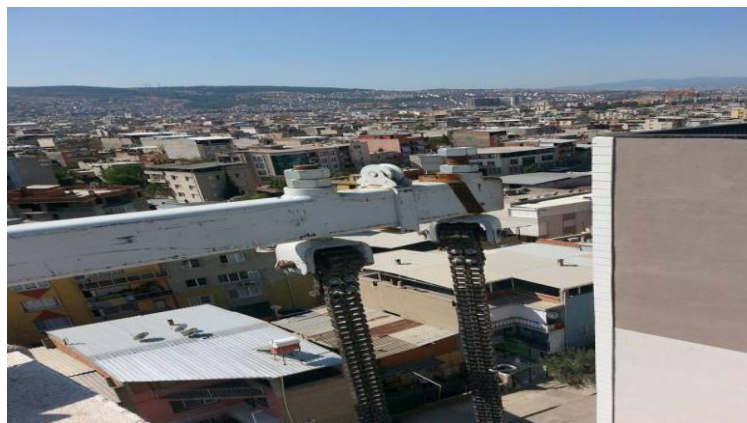
The platform fixed to building with suspensions legs can go along the facade via two electric motors enabling movement on the chains attached to the legs. The upward and downward movement, upward run and downward run of electric motor are performed by a cableway control system with one key related Fig. 5).

Figure 5. The chain attaching the platform to suspension leg

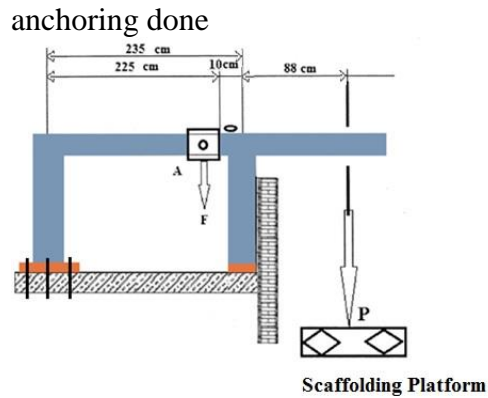
The “P” (Fig. 7) value which gives to the load transferred by the scaffolding platform at the time of accident and calculated as follows: $F*10=P*88$ (For $F=37.440 \text{ kg}$) and it was obtained as $P=4.254 \text{ kg}$.

As the result of the above performed calculations done regarding this situation 39.6 tons of force fell on the dowel at the most negative point. This force cannot be carried regardless of kind of

Figure 7. Scaffolding Platform and Supporting Leg

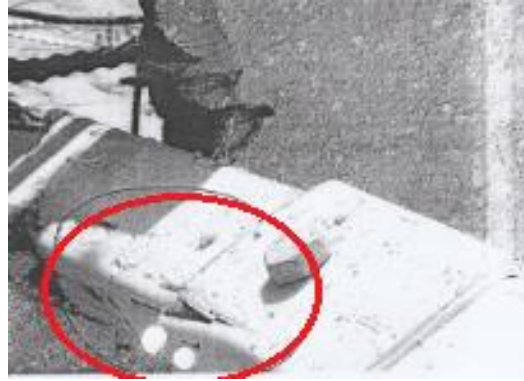
The maximum weld towing capacity for Steel 52 as per the standard TS EN 648 is $\sigma_{max}=52\text{kgf/mm}^2$. F value is the resultant tensile force of the accident. Then F is calculated as; $F=\sigma_{max}*\sum Ak= 52*2*45*8 = 37440 \text{ kg}$. In order to calculate the force at the ending zone of the supported leg, the static behavior of the system should be taken into account (Fig 6).

Figure 6. Corner Weld Application
