An Experimental Study on the Hysteric Behavior of Composite Shear Walls

^{*1}Mehmet Haşim Kısa, ²S. Bahadır Yüksel and ³Naci Çağlar

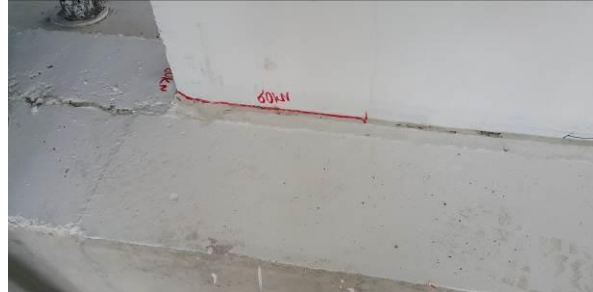
Figure 6. A thin crack line under a 60 kN.

During the force-controlled protocol experiments, small cracks extending up to a level of 1.5 m appeared in the shear wall end zones when a force of ± 50 kN was applied (Figure 5). A thin crack line, with the appearance of a bending crack, occurred in both the foundation and the shear wall when a 60 kN load level was applied (Figure 6).

These cracks parallel to the horizontal plane indicated that the structure exhibited ductile behavior at small displacement levels. In this case, the top displacement was measured as 5 mm. The fact that the cracks started to form at the shear wall end zones indicated that the strains in the cross section of the shear wall particularly concentrated in this zone. Long, 45 degree shear cracks

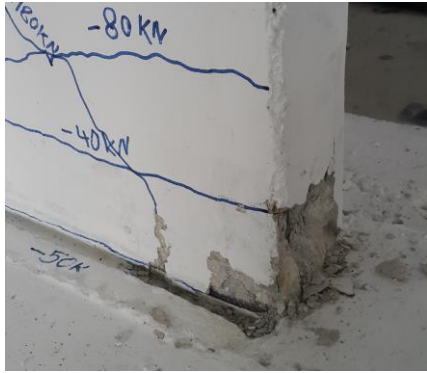
Figure 8. Crushing effects in the pressure zone.

After this phase, the bending behavior observed in the structure was gradually replaced by a shear behavior. In the ensuing cycles, the sample was displaced by 28 mm under a -180 kN load. The crushing effects in the pressure zone at the junction between the shear wall and the foundation, as well as the crack widths in the tensile zone, gradually increased (Figure 8). The shear wall was displaced by 45 mm under ± 200 kN load. When concrete covers in both end zones went into pieces, the bended sheet plate became visible (Figure 9). The shear wall reached maximum load level at

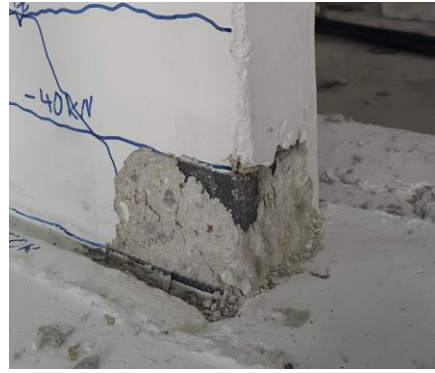
Figure 9. Bended sheet plate becoming visible in the shear wall end zones.

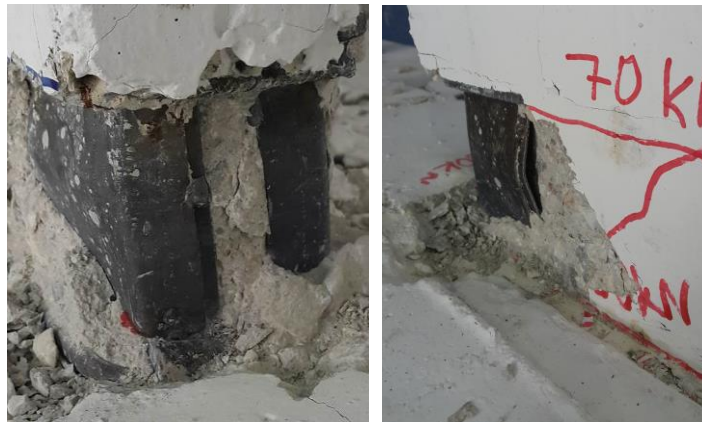
Figure 10. Buckling occurring in the bended sheet plates at the right end of the shear wall under 202 kN.

approximately 202 kN, and made a 47 mm displacement. After this load level, cracks tended to expand rather than progress. Since the load on the element could not be increased any further beyond this stage, the experiment was continued with the displacement controlled protocol. Buckling occurred in the bended sheet plates at the right end of the shear wall (Figure 10).

Following the buckling of the plate, it could no longer carry further loads. The target displacement was then determined as -65 mm, and the shear wall was forced up to that point. The experiment was ended after the plate lost its load bearing capacity due to the bending and full buckling of the sheet plate at the left end of the shear wall, just below the tack weld connecting the bended sheet plates to one another. The final crack distribution of the experimental specimen at the end of the loading procedures is shown in Figure 11.

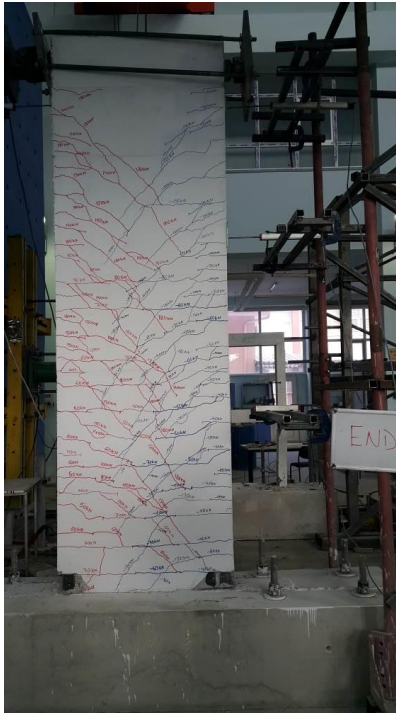
Figure 11. The final crack distribution of the experimental specimen at the end of the loading procedures.

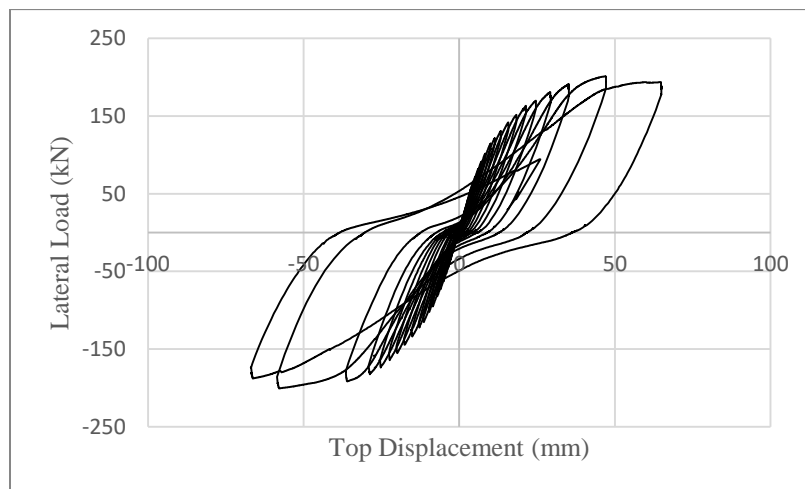
Figure 12. Lateral load versus top displacement curves.

The graph of the load-top displacements obtained based on the measurements is given in Figure 12, while the load-displacement envelope formed by connecting the extremum points is given in Figure 13. As can be understood from this graph, the composite shear wall with L-section end zones exhibited a ductile behavior. Hence, sudden load losses were not experienced. Values for the angle of inter-story drift, obtained by dividing the top displacement with the shear wall height

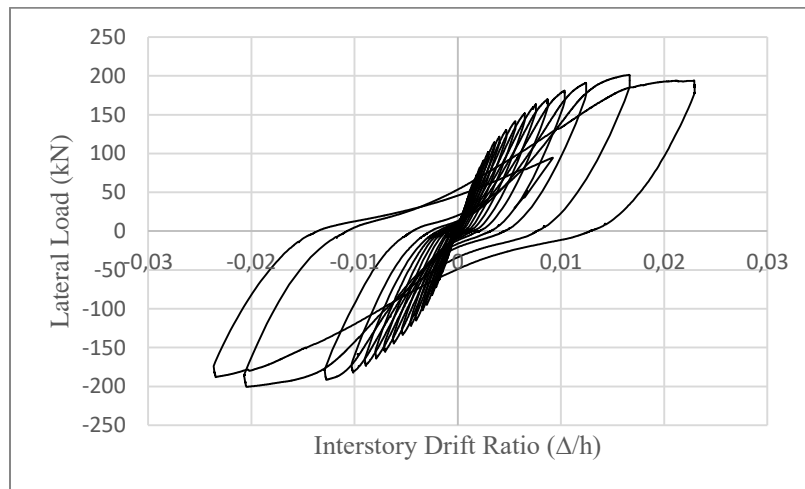
Figure 14. Lateral load vs interstorey drift ratio.

starting from the top level of the foundation, are presented in Figure 14.

When the values were evaluated, it was observed that the shear wall element was able to carry loads of up to a maximum 2.2% inter-story drift angle. It is believed that further tightening the weld steps of the welding areas used for connecting the bended sheet plates at the buckling zones (for the purpose of forming a sufficiently thick bending sheet plate section) would help shortened the length of buckling, and that the structure would consequently exhibit a more ductile behavior.
