# Behavior of Reinforced Concrete Walls with Mesh Reinforcement Subjected to Cyclic Loading

## Abstract:

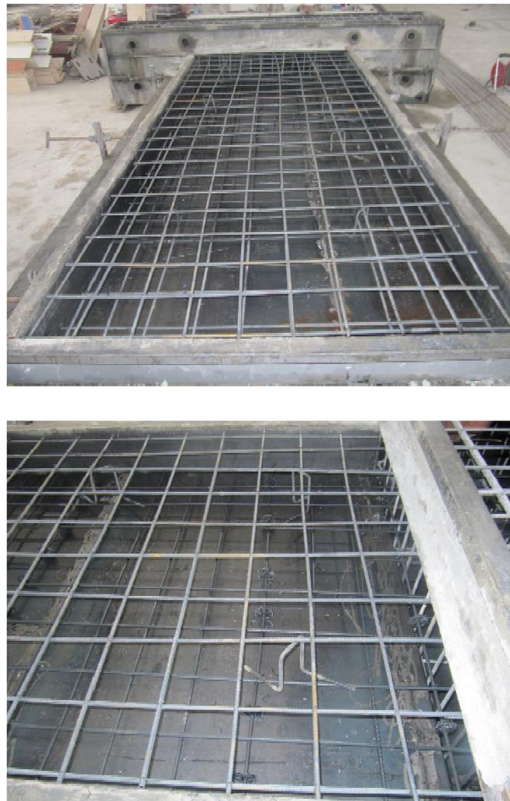
**Figure 3.** General view of the SW test specimen in the construction stage

The experimental work described herein involves the testing of a full scale SW. The test specimen was designed to represent the lower stories of structural walls in high-rise buildings. Testing program consisted of lateral reversed cyclic loading. Reinforced concrete wall specimen was designed and labeled as SW. The SW was 3.2m tall, 1.4m length, 0.2m thick and had an aspect ratio (height-to-width ratio) of 2.285. The dimensions of the elevation view of the SW specimen are illustrated in Figure 1. The wall was located on the building perimeter next to a stairway shaft. The applied gravity loads produced a compressive stress of 1% of the nominal concrete compressive strength and were therefore ignored in the test program. A detailed description of the experiments and a compilation of all test data are available elsewhere [9]. Mesh reinforcement for the walls consisted of 8 mm diameter deformed bars. The SW was constructed with normal-strength concrete having a nominal compressive strength  $f_c = 30\text{Mpa}$  and reinforcing steel with a nominal  $f_y$  of 500Mpa and  $f_u$  of 550 MPa. Double-layer mesh reinforcement was placed in the SW test specimen. Bar spacing in the vertical and horizontal directions were 150 mm. Figure 2 shows the plan view of the reinforcement layouts of the shear-wall test specimen. The ratio of wall reinforcement along each orthogonal direction was 0.0036. SW test specimen was monotonically constructed and manufactured on the foundation having 0.7m width, 3.0m length, and 0.5m thickness. The rigid foundation was clamped to the laboratory strong floor by high-strength steel bolts. The photograph in Figure 3 shows the general view of the shear wall test specimen in the construction stage. Figure 4 shows the pouring the concrete of the SW test specimen.

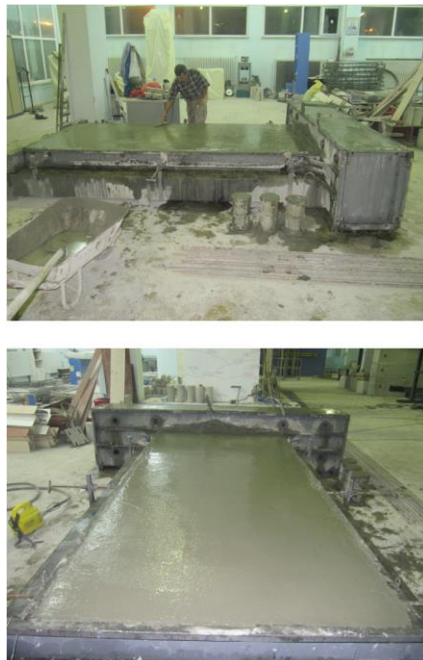
**Figure 4.** Pouring the concrete of the SW test specimen

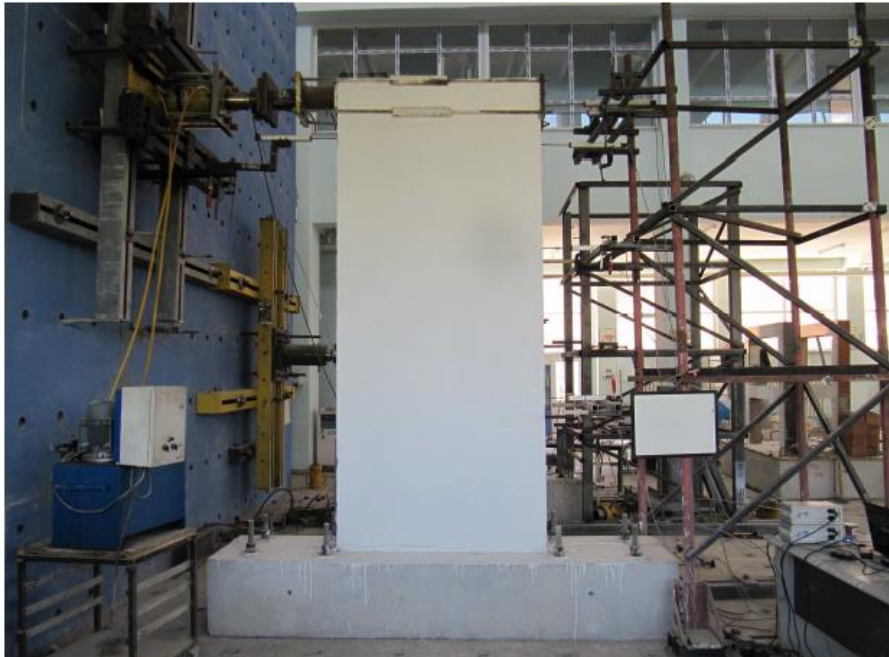
**Figure 5.** Test setup, loading system and instrumentation of SW test specimen

Figure 5 shows the test setup used in the experimental program. The testing system consisted of strong floor, reaction wall, loading equipment, instrumentation and data acquisition system. The lateral loading system consisted of a load cell, hydraulic jack and hinge. Instruments were used to measure loads and displacements for the SW test specimen. Load cell measured the lateral loads applied to the specimen. Strain gage-based linear variable differential transformers (LVDTs) were used to measure the displacements. Five LVDTs were mounted to measure the lateral displacements over the wall height. An LVDT was mounted horizontally on the foundation to monitor any horizontal slip of the foundation along the reaction floor.

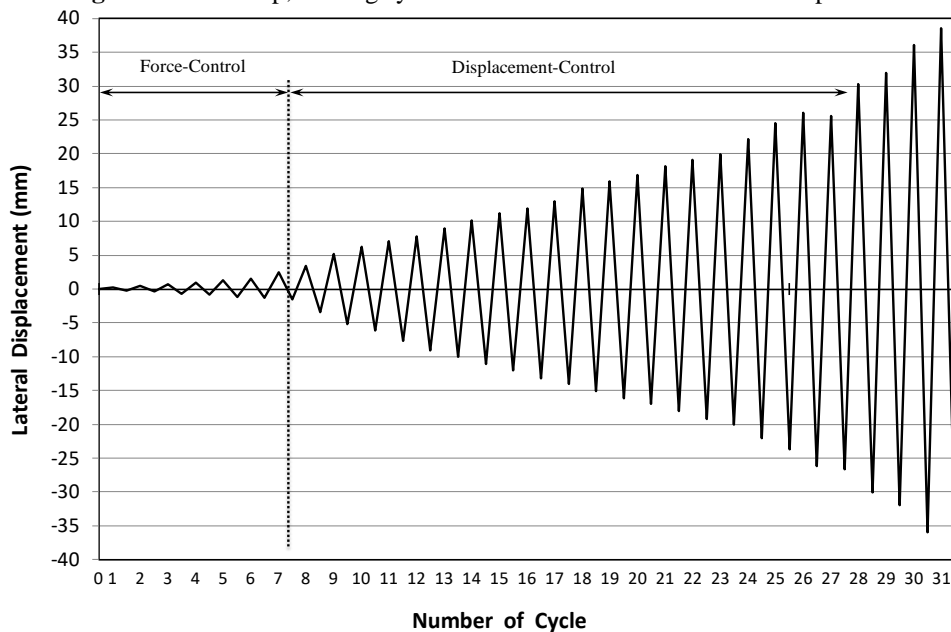
**Figure 6.** Reversed-cyclic lateral displacement history

Test was conducted by controlling the horizontal top displacement imposed by the actuator. The specimen was subjected to reversed-cyclic lateral loading. A reversed-cyclic lateral displacement history shown in Figure 6 was applied to SW test specimen. The measurements were recorded by a computer data acquisition system. During the tests, cracks and failures were observed carefully and recorded by hand. Movements of the foundation block and actuator resisting system was monitored and removed to obtain the wall deformations relative to the foundation. The test,

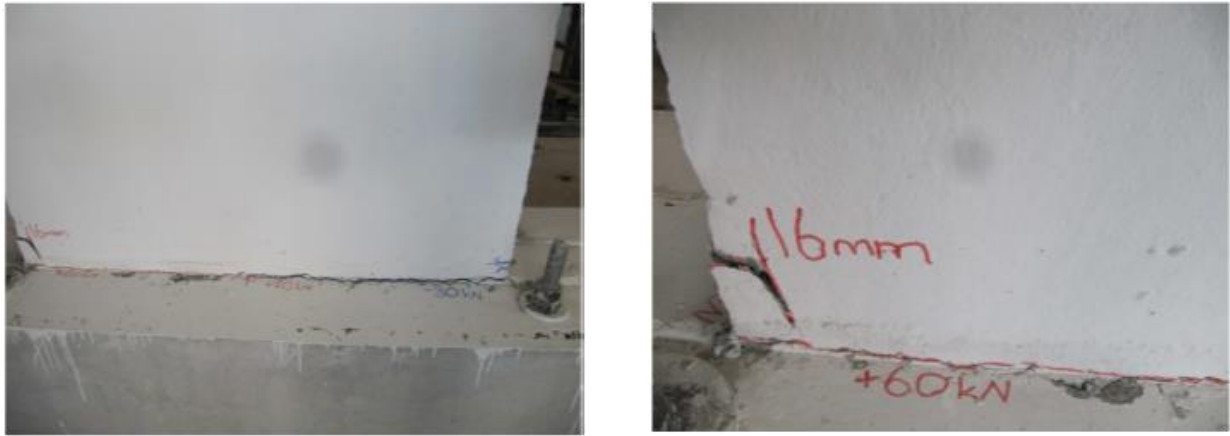
**Figure 7.** Cracking patterns of SW at 16 mm lateral displacement

The initial cracks in the concrete occurred at an average measured lateral load of +/-60 kN of the SW. The cracks were nearly horizontal and formed from the edges of the SW. Being that the cracks are mostly horizontal, it can be concluded that the response of the SW is governed by bending. As the loads increased, the edge cracks progressed toward the centre of the wall. This was followed by the crushing of the concrete and buckling of longitudinal reinforcement in the boundary regions. Figure 7 shows the cracking patterns of SW at 16 mm lateral displacement. The performed test showed an expected flexure-dominant behavior in accordance with the design process, crushing of the compressed concrete and the tearing of the tensioned steel reinforcement. Buckling of longitudinal reinforcements can be seen in Figure 8. The final stage was buckling of the boundary reinforcement and tearing of all the mesh reinforcements at the foundation level. The test was stopped due to tearing of the all the vertical reinforcements and buckling of the boundary reinforcement. Collapse of SW characterized by the existence of a wide crack at the base level (Figure 9), thus showing a higher tendency to localize plastic deformations in mesh reinforcement. All the longitudinal bars just above the foundation level were broken. The concrete in the boundary regions were crushed. Figure 9 shows overall condition of SW test specimen at end of test. Figure 10 shows the horizontal lateral force - lateral top displacement curves for the SW. Maximum lateral top displacement was 38.5mm and the maximum lateral load capacity of the SW was 108 kN. Lateral force versus - lateral displacement at 2.0m and 1m above the foundation levels were presented in Figure 11 and Figure 12, respectively. Maximum lateral displacement at 2.0m above the foundation levels was 27.4mm. The lateral load- drift ratio relationship of the wall specimen is plotted in Figure 13. Maximum lateral top drift ratio was 1.26 for SW test specimen. Lightly reinforced concrete SW wall test specimens formed only a single crack in the plastic hinge region as opposed to the expected distributed cracking. Because of the lack of distributed cracks, the inelastic deformation of the SW test specimen was concentrated in a significantly reduced plastic hinge length, resulting in the premature fracture of vertical reinforcement, as shown in Figure 9. Furthermore, large crack openings at the wall base can cause additional problems, such as large axial elongations, wall sliding and early reinforcement buckling. In response to the observed performance of lightly reinforced concrete SW to ensure that yielding of reinforcement can extend beyond the immediate vicinity of a single primary crack.

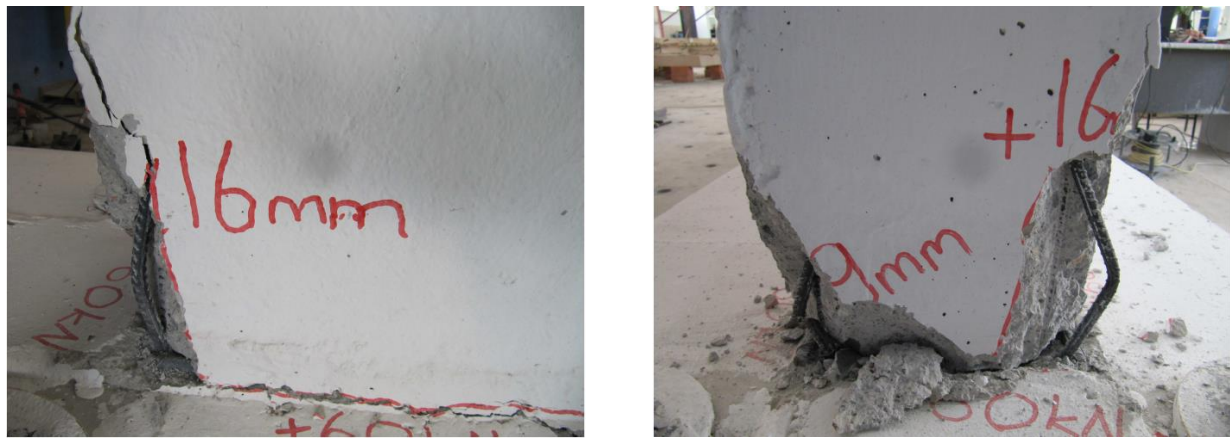
**Figure 8.** Buckling of longitudinal reinforcements

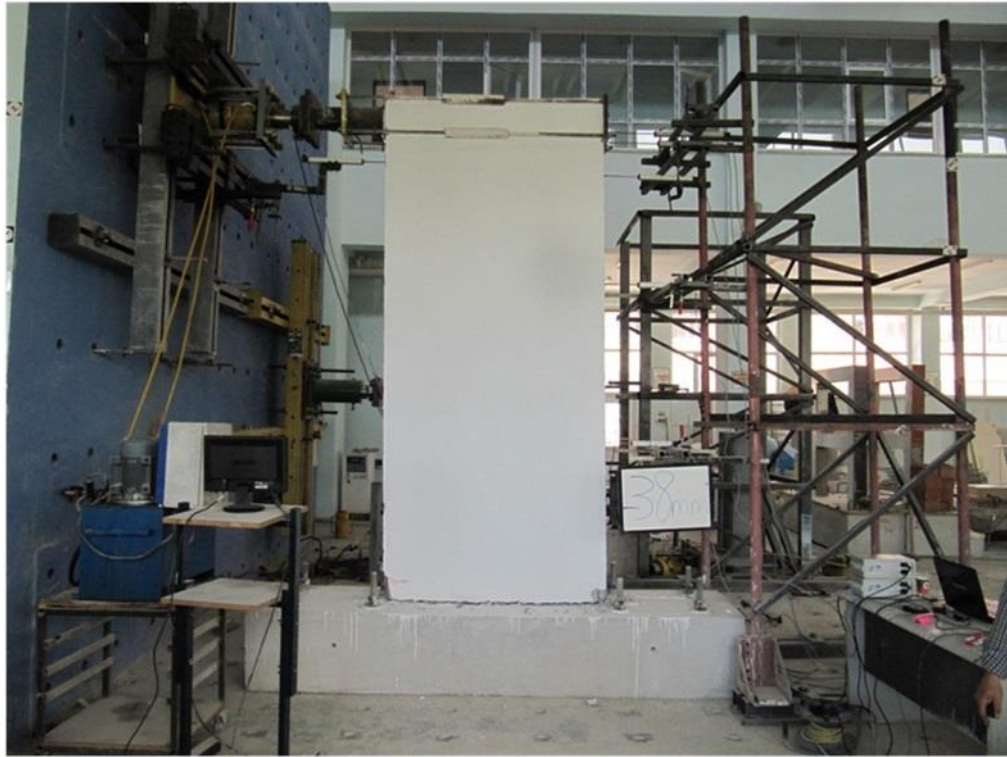
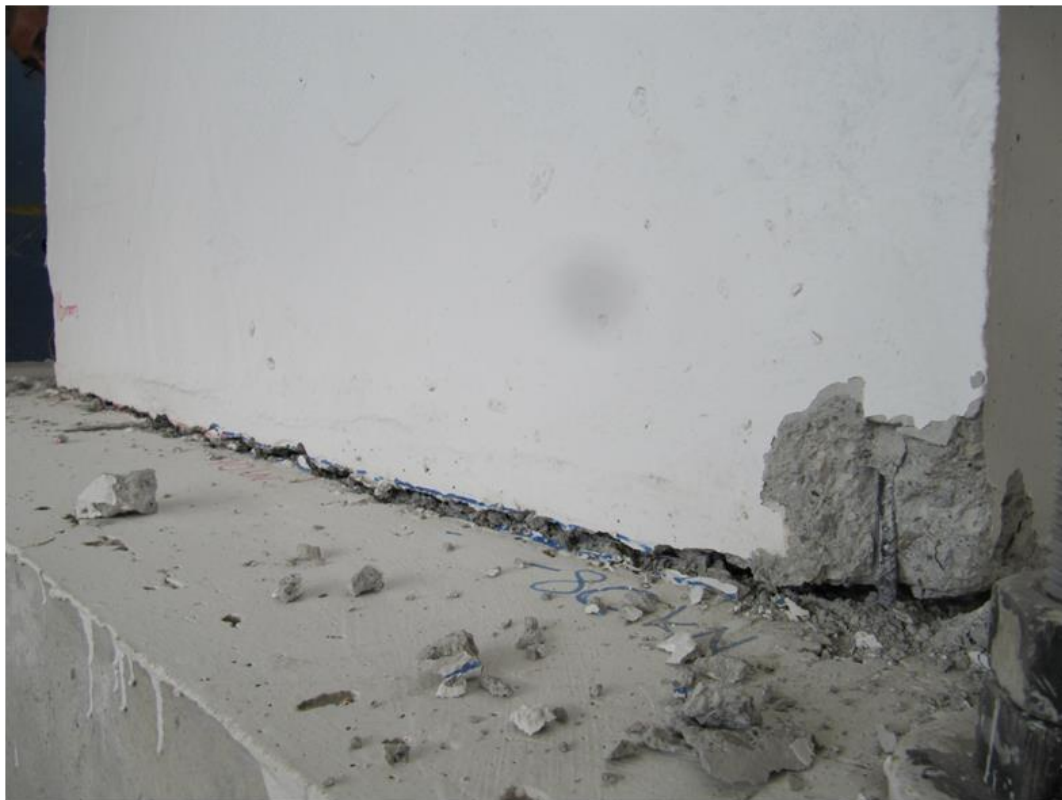
**Figure 9.** Overall condition of SW test specimen at end of test

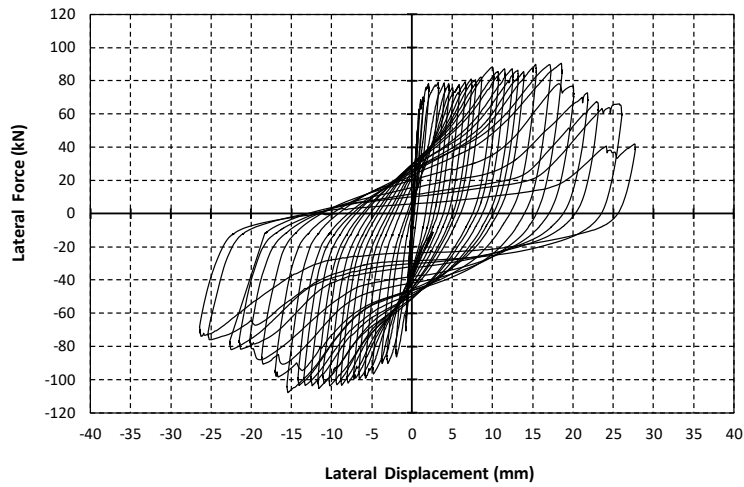
**Figure 11.** Lateral force versus - lateral displacement relationships 2.0m above the foundation level

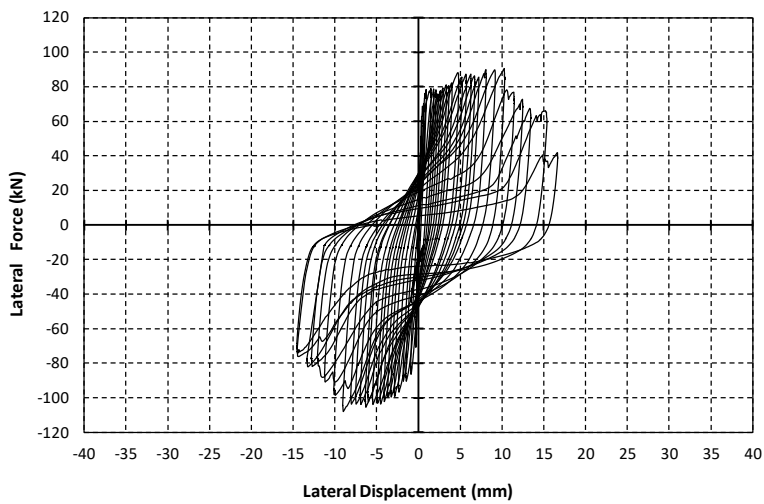
**Figure 12.** Lateral force versus - lateral displacement relationships 1.0m above the foundation level
