Differential Settlement Problem of Buildings on the Rock and Filling

Abstract:

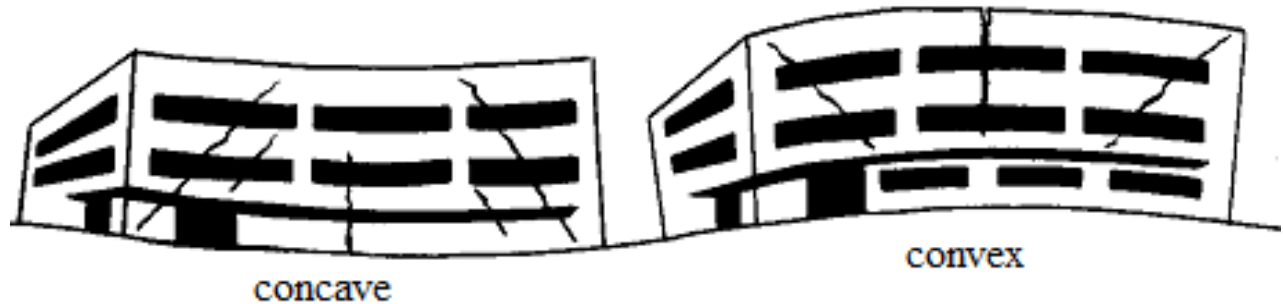
Figure 1. Settlement damages on buildings [3]

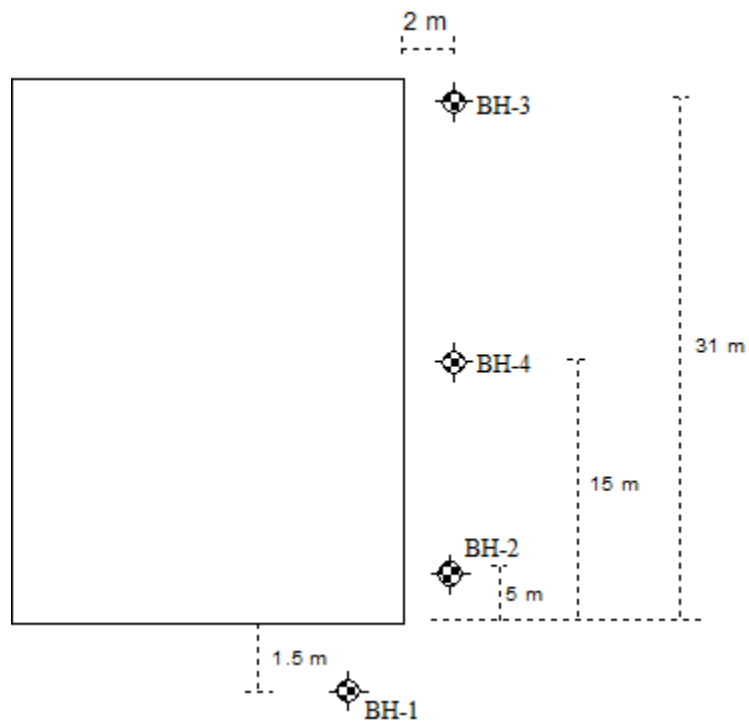
Figure 3. The locations of the borings

profile under the building, 4 borings were performed and some disturbed samples were taken. The locations of borings can be seen in Figure 3.

According to the borings, It has been understood that some parts of the buildings were directly seated on the bedrock while the other parts on the filling. Starting from the existing ground level, the depth of the filling has been determined to be between 3.50 m – 2.20 m at the front side of the building and around 2 m at the center of the building. It has also been determined that there is no filling at the backside of the building and foundation was directly seated on the bedrock (Figure 4).
