Seismic Performance Evaluation of a Train Station Building Considering Earthquake-Induced Pounding Effects

Abstract

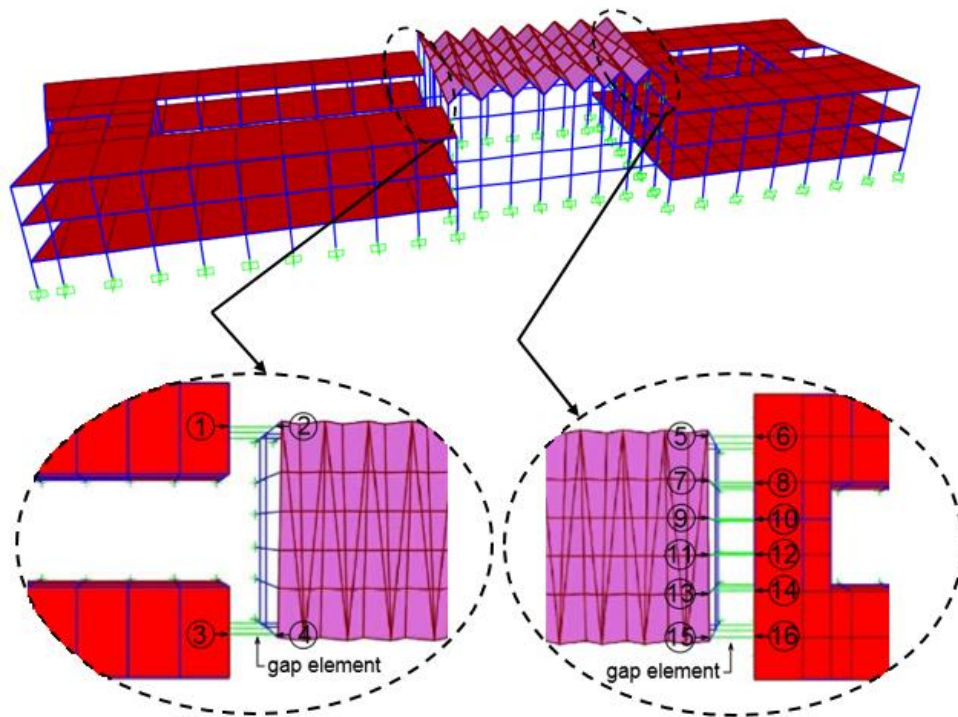
Figure 3. Three dimensional view of blocks and pounding model in the Train Station Building

The Train Station Building has three blocks as shown in Figure 2. Three-dimensional views and gap elements belong to three blocks of the Train Station Building are shown in Figure 3. The total area covered by Blocks 1, 2 and 3 are 651.57m², 267.57m², and 474.41m², respectively.
